SAFETY ARTICLE

Electrocution Risks When Working Near Overhead Power Lines

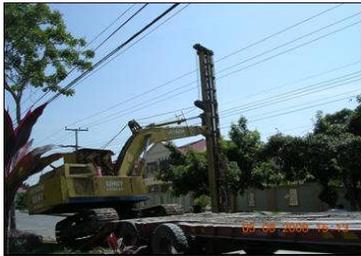
Picture 2a

On 4 August 2008, a driver of a lorry-trailer was uploading a mobile piling rig onto the trailer. In the process the mobile piling rig moved too close and eventually *came into contact* with the LIVE 11 kV (11,000 volts) overhead power lines (refer picture 2a and 2b). This contact energized (charged) the lorry at 11 kV. The electric charge was insulated from the ground by the lorry's tyres and dry tarmac road surface. However when the driver tried to open the door of the vehicle, he became a path to the ground for the electric current. The driver was electrocuted and died on the spot (refer Picture 2c).

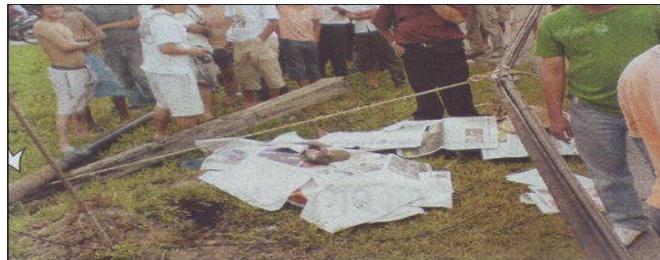
Picture 3c

On 4 September 2008, a team of workers for a telecommunication company were removing an existing wood pole and wanted to replace it with a steel pole to support telecommunication cables. The steel pole was about 24.4 feet in height whilst the nearby 11 kV overhead power lines was at 22 feet above ground level (which is well above the statutory requirement under The Electricity Rules 1999 (refer picture 3a and sketch 3b)). When the workers were erecting the steel pole, they moved it *too close* to the LIVE 11 kV overhead power lines. The resulting electrical flashover through the air provided a path to the ground for the electric current. The three workers holding the steel pole stood no chance and were electrocuted (refer picture 3c). The fourth worker was escaped but sustained electrical burns on his right foot.
